# Brine seepage tracing in a damaged dam slope using elapsed-time electrical resistivity tomography

The electrical resistivity tomography technique is a geophysical inspection method widely used for several investigations, such as mining exploration, fault localization, groundwater flow, geological exploration, and pollution zones. Infusing brine into substructure can increase conductivity and becomes a useful medium to trace the path of the seepage flowing in rockfill dams. In this article, an elapsed-time electrical resistivity tomography technique was developed to monitor the potential seepage in the damaged dam slopes nearby a concrete spillway. Tracing the downhole brine seepage could effectively identify the possible direction and path of the seepage flowing through the rockfill dam mass in a few hours. The spatial distribution variations of electrical resistivity tomography images can also provide information about the potential sliding surface and the accumulation zones of the seepage in the downstream side slope of the dam.

**Keywords:** Electrical resistivity tomography, Brine seepage tracing, Elapsed-time, Slope failure, Groundwater, Dam.

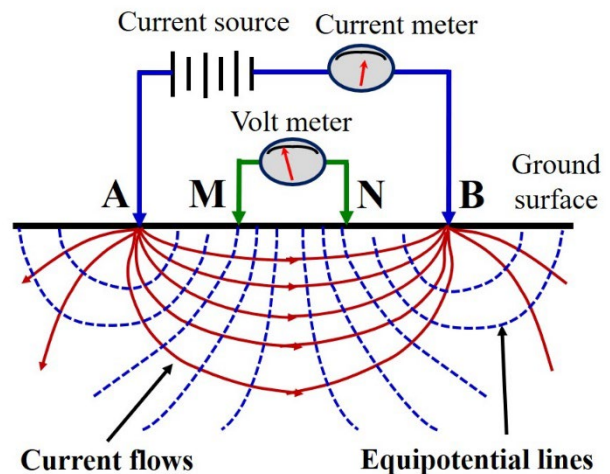
The principle of electrical resistivity tomography is to develop an artificial potential field by probing one pair of current electrodes, labelled as A and B, into the ground around a target zone, as shown in Fig. 1. Two extra electrodes, labelled as M and N, are used to measure the ground resulting potential difference. The most common resistivity systems use direct current, DC, or alternating currents, AC, with very low frequency. Some electrical resistivity tomography techniques use line electrodes or buried electrodes, but the most commonly-used method involves point electrodes on the surface. Typically one pair of steel electrodes is used to inject current and another pair is used to measure the potentials. This type of four-electrode measurement avoids erroneous external influence on measurements from contact resistance at the interface between the electrode and the ground (Sjödahl, 2006).

Fig. 1. Electrical resistivity tomography inspection schematic

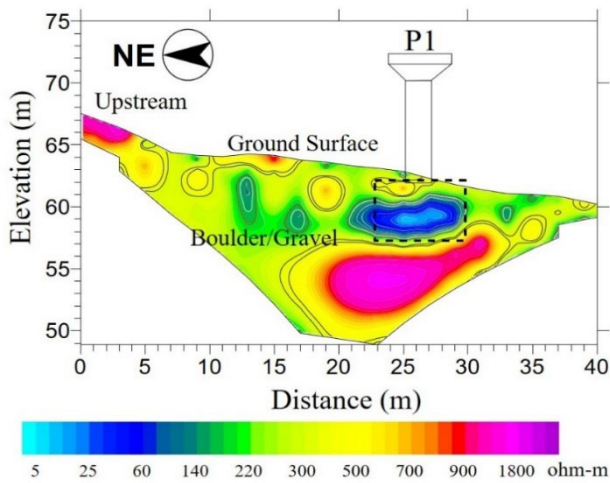
A typical apparent resistivity image is usually displayed with a visible-light mode, which corresponds to the resistivity values varying from 2,000 to less than 1  $\Omega \times m$ , as shown in Fig. 2. The typical resistivity values for sediments composed of boulder, gravel, and sand are more than 60  $\Omega \times m$ , corresponding to the pink, red, orange, yellow, or green zones. Water, pollutant, or metal represents low resistivity zones, corresponding to the blue and light blue shades. A significant low-resistivity closed-contour zone is usually located right below the bridge pier, and the bottom of this low-resistivity zone, marked with a dashed-lined rectangle, can be identified as the depth of the bridge foundation, which usually consists of conductive reinforced steel rebars. The locations and depths of any possible subsurface anomalies can be effectively identified with this two-dimensional resistivity image profiles. In addition, the most commonly-useful array configurations are pole-dipole and dipole-dipole methods for foundation inspection (Wang et al., 2015).

Fig. 2. Electrical resistivity tomography inspection on an unknown bridge foundation

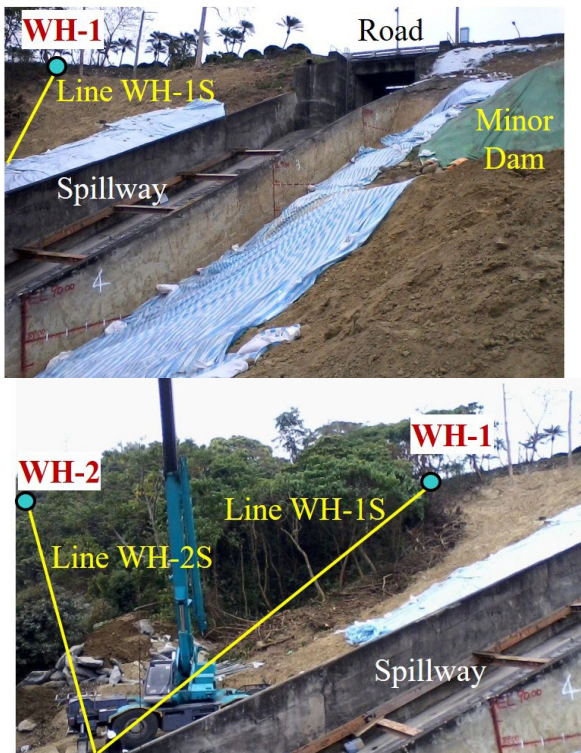
In 2013, a typhoon and an accompanying storm triggered the surface sliding of the downstream slope along the spillway again. Leakage and lateral movement were again found on the spillway channel walls (NCTU, 2005; Liming, 2014). Substrate cavitation right below the spillway bottom and piping through the spillway walls directly undermined the stability of the spillway and led to severe cracking on the spillway bottom. Fig. 4 shows the on-site images of the slope failure and damaged spillway channel. The shallow surface sliding removed more than 3.8-m deep topsoils beside the spillway walls. Plastic canvases were covered the

Fig. 4. Surface sliding along the damaged spillway

sliding zones to prevent from more surface erosion temporarily. Temporary steel supports were installed along the spillway walls, and substrate refill and retrofitting construction on the channel bottom were conducted for recovering its original function. The post-event report also suggested an in-depth field survey to find the flowing groundwater of the slope failure nearby the spillway (Liming, 2014).

downstream slope of the rockfill dam. The most intensive resistivity variation zones represented the most intensive impact positions from the injected brine. Within the first 240 min, the relatively significant resistivity variations (-20% maximum) occurred at the sandstone/mudstone interlayer, around the elevations of 85~100 meters and the measurement distances of 15~30 meters. As time increased, the resistivity variation range expanded outward, but relatively limited. As brine injection stopped, the spatial expansion of resistivity variation vanished in 840 min. This phenomenon possibly revealed that the brine seepage is determined by near-borehole diffusion. Therefore, coverage on the resistivity variation depended upon continuous brine infusion. No significant seepage direction or accumulation zone developed in the elapsed-time variation images of electrical resistivity tomography. In fact, broomy bushes and grass cover the whole slope surface, and no surface erosion or sliding scars were found along survey Line WH-2S, as shown on the right side of Fig. 4.

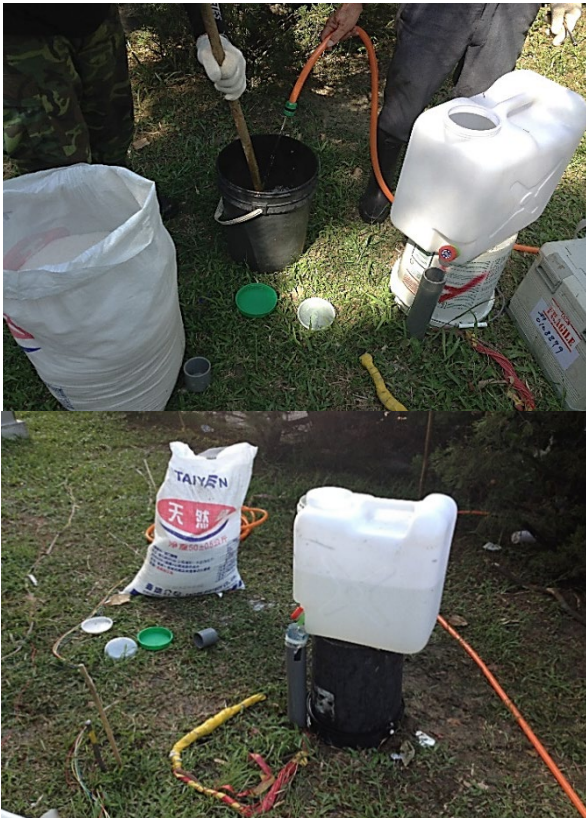
The concentrations of brine are listed in Table 2 for these two electrical resistivity tomography survey lines. Fig. 5 shows the preparation photos of brine seepage tracing with electrical resistivity tomography technique at two borehole sites. The brine was continuously infused into the dam mass from water tanks at these two boreholes through the PVC pipes. The resistivity variation images were traced at 30, 60, 120, 180, 240 and 840 min after brine injection (Fig. 6). Each inspection period lasted up to 10 min.

Fig. 5. Mixing infused brine

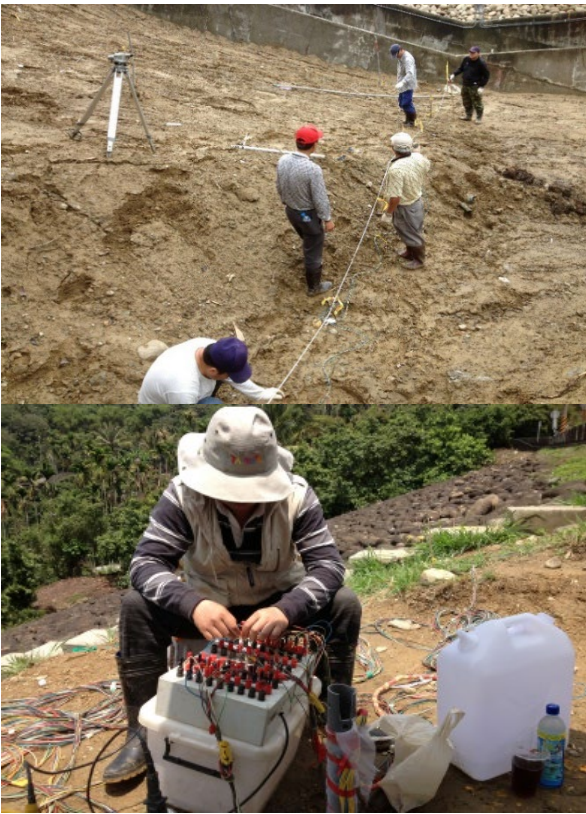
Fig. 6. Brine seepage tracing with electrical resistivity tomography technique

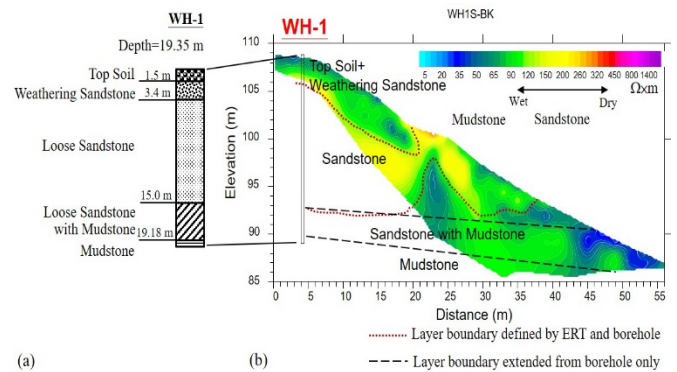
In Fig. 7(a), the geomaterials in the WH-1 borehole sampling, in series, consisted of top soil, weathered sandstone, loose sandstone, loose sandstone with mudstone, and mudstone. The background image of electrical resistivity tomography along survey Line WH-1S, as shown in Fig. 7(b), had a good consistency with the geological findings at borehole WH-1. The black dashed lines represented the geological layer boundaries extended from the borehole sampling with the dip direction of geological layers. The red dotted lines represented the geological layer boundaries jointly defined by both the electrical resistivity tomography image and borehole sampling information. In the background image of electrical resistivity tomography, the top soil and weathering sandstone layers corresponded to relatively low resistivity zones, i.e., light blue and green modes, scattering from the ground surface to depths of 3~5 meters. The yellow, light green, and orange shades, i.e., the relatively high resistivity zones, indicated the sandstone overlaying sandstone with mudstone, i.e., a relatively low resistivity value zone.

Fig. 7. (a) Geological column at borehole WH-1; (b) background image of electrical resistivity tomography along investigation Line WH-1S (Geological profile data from Liming, 2014)

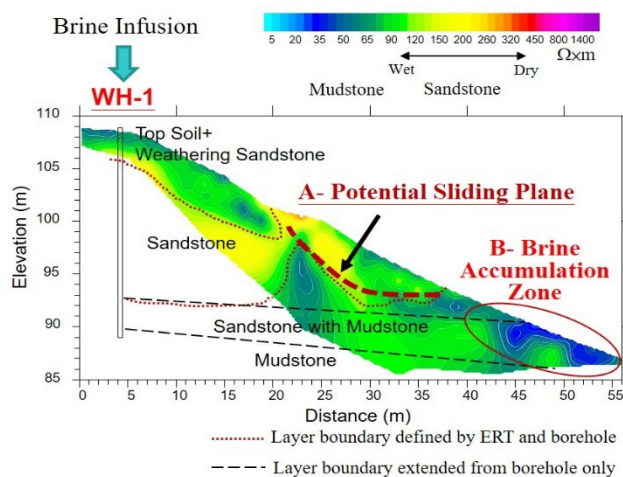
**Fig. 9.** Possible sliding plan and seepage accumulation zone along survey Line WH-1S

In addition, the terminal of the brine seepage will accumulate at the slope toe, labelled as an askew red oval, as shown in Fig. 9. Consequently, the seepage standing on

the slope toe could not only lead to groundwater effusion but also gradually soften the strengths of soils. Accordingly, an on-site rusty fountain at the lower slope surface verifies the existence of the groundwater flows identified on the electrical resistivity tomography-based brine tracing image. The slope surface of undermined sandstone with mudstone reveals shallow surface sliding and erosion as well.

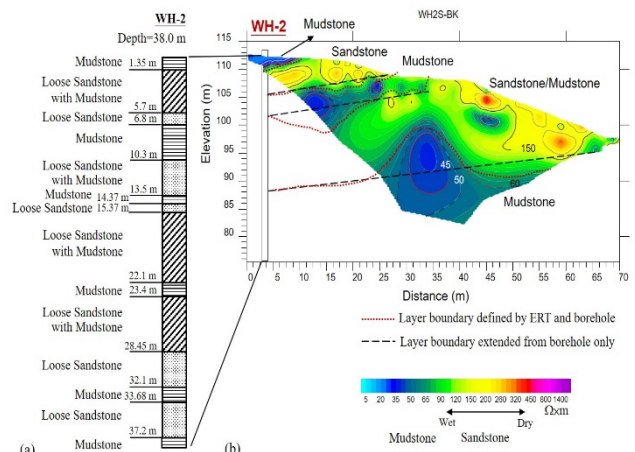
In Fig. 10(a), the geomaterials in the WH-2 borehole sampling from the ground surface are, in series, composed of mudstone, loose sandstone with mudstone, mudstone, interlayered loose sandstone/mudstone, mudstone, loose sandstone with mudstone, loose sandstone, mudstone, loose sandstone, and mudstone. The background image of electrical resistivity tomography along survey Line WH-2S, as shown in Fig. 10(b), had a good consistency with the geological findings at borehole WH-2. The black dashed lines represented the geological layer boundaries extended from the borehole sampling only. The red dotted lines represented the geological layer boundaries jointly defined by both the electrical resistivity tomography image and borehole sampling information. In the background image of electrical resistivity tomography, the mudstones usually corresponded to relatively lower resistivity zones, i.e., dark blue, blue, and green shades. The yellow, light green, and red modes, i.e., relatively higher resistivity zones, indicated the loose sandstone mixing with mudstone or interlayered loose sandstone/mudstone.

**Fig. 10.** (a) Geological column at WH-2; (b) background image of electrical resistivity tomography along investigation Line WH-2S (Geological profile data from Liming, 2014)
